Case Study – Robinson Pool

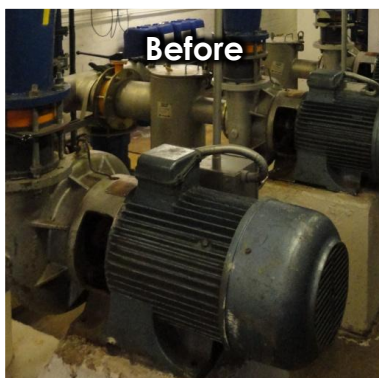
Before

The existing installation of three 40-year-old Worthington Simpson pumps, using inefficient 9.3kW motors and installed with non-DIN standard cast-iron pipework, were leaking excessively. The build-up of scale on the inside of the pipework added to the inefficiency, as well as creating water quality problems.

Both the pumps and the pipework needed replacing. Having identified the specific issues and challenges, deckpro pumps specified inverter-driven Modus pumps connected to a bespoke-made control panel, to adjust the speed of the pumps automatically when the demand reduced (for example, when there were no swimmers in the pool).

The new pipework was pre-fabricated, brought to site ready-to-install and craned into place, ensuring that the pumps and pipework could be replaced in one night so that the pool could remain fully operational during normal opening times.

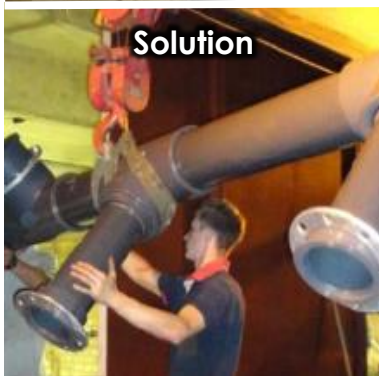
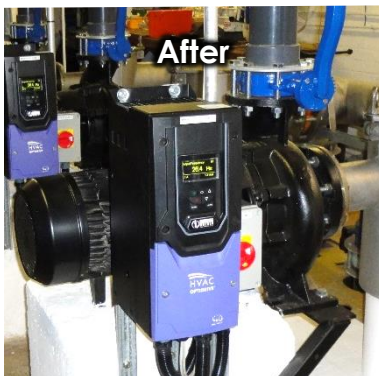
After

The result is a highly-efficient, low-maintenance pumping operation. The pumps use a combined total of about 82% less energy than the before, the quality of the pool water is improved, and this has been achieved with no inconvenience to customers or staff.
